**Sediment Source Investigation
and Sediment Reduction Plan for
the North Fork Elk River Watershed
Humboldt County, California**

**The Pacific Lumber Company
Scotia, California**

**Pacific Watershed Associates
Arcata, California
(707) 839-5130
June, 1998**

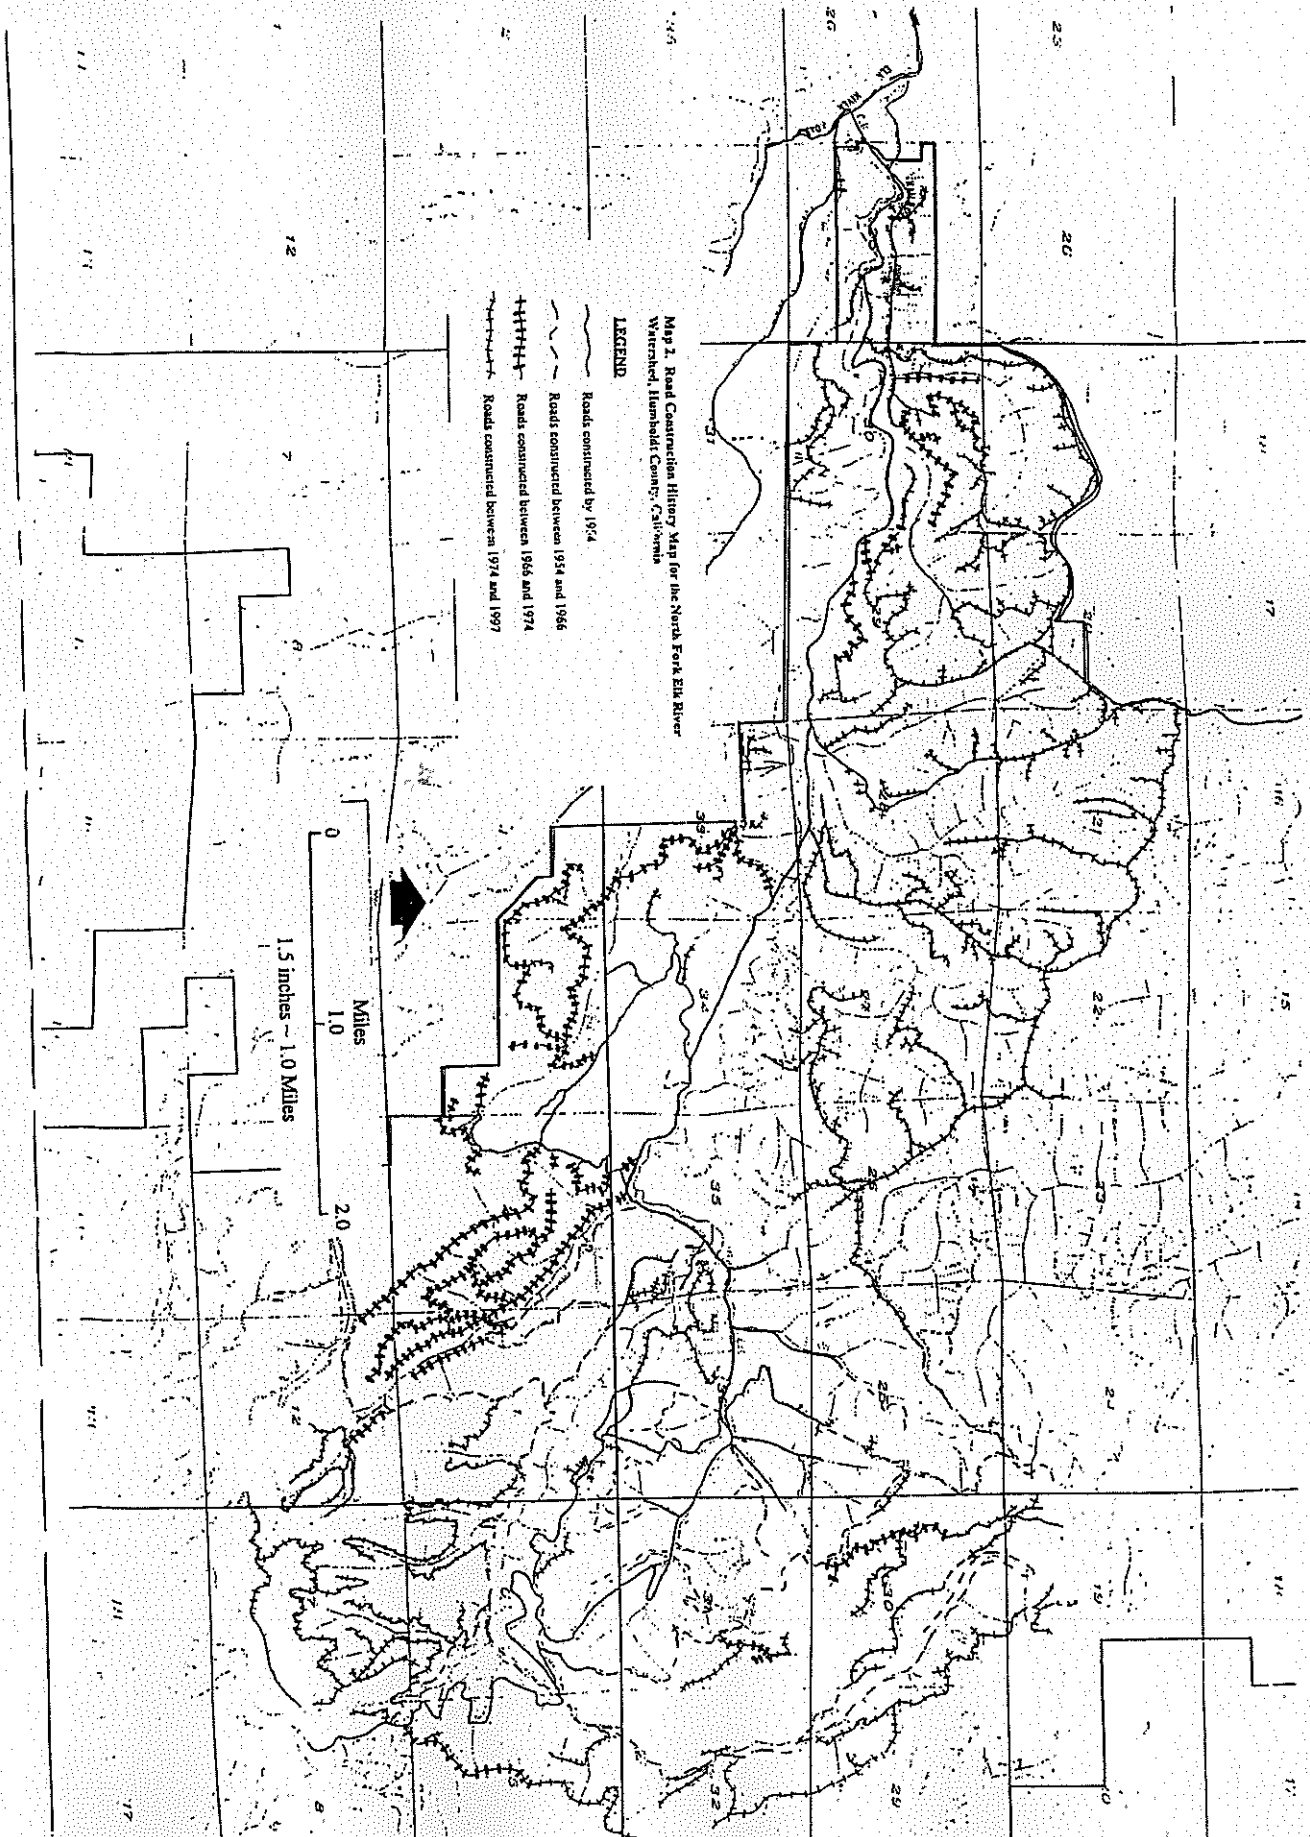
- Roads constructed by 1974
- - - Roads constructed between 1934 and 1966
- + + + + + Roads constructed between 1966 and 1974
- - - - - Roads constructed between 1974 and 1997

0 1.0 2.0
 Miles
 1.5 inches ~ 1.0 Miles
